RE: Updates to Groundwater Permit Application

**Utah Groundwater Discharge Permit Application
for
Utah Alunite Corporation
Blawn Mountain Project**

**February 4 , 2014
Updated March 1, 2014**

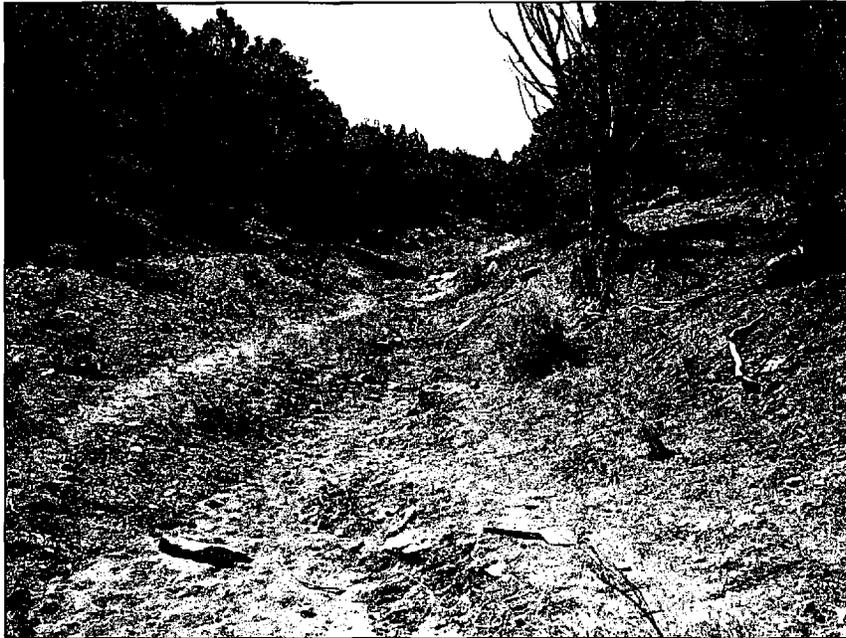
Photo 7.1 Typical Drainage Conditions

The drainage geomorphology for both Willow Creek and Blawn Wash consists of ephemeral channels eroded into the underlying bedrock creating narrow valleys that hold the streams, and does not contain any perennial surface water sources. Photo 7.1 shows a typical section of the upper Willow Creek drainage. Channels are incised in some reaches and essentially undefined in others, riparian vegetation is lacking, and bed/bank sediment movement is evident. In areas where the channels are incised, the channels are filled with alluvial sediments of varying thickness, which are described as generally dry with highly mobile beds of sands and fine gravels. Typically, the sediments hold a normal flow channel about 15 to 20ft wide that meanders through the valley fill. Within this normal channel, a shallowly incised low flow channel typically exists. The runoff regime of these channels is controlled primarily by local summer thunderstorms that generate infrequent and short-lived, but often intense, flash floods.

Surface water is very limited in the Permit Boundary. No continuous flow in these channels has been reported or identified. Norwest (2013a) conducted a spring and seep inventory that found very limited water sources within the Permit Boundary with many of the springs and seeps limited mainly to the drainage channels. Many “springs” were repeated occurrences of up gradient spring/seep water that percolated into alluvial fill within the valley. This water is often exposed subsequently further down drainage in areas where the alluvial fill thins and more resistant bedrock forces water back to the surface.

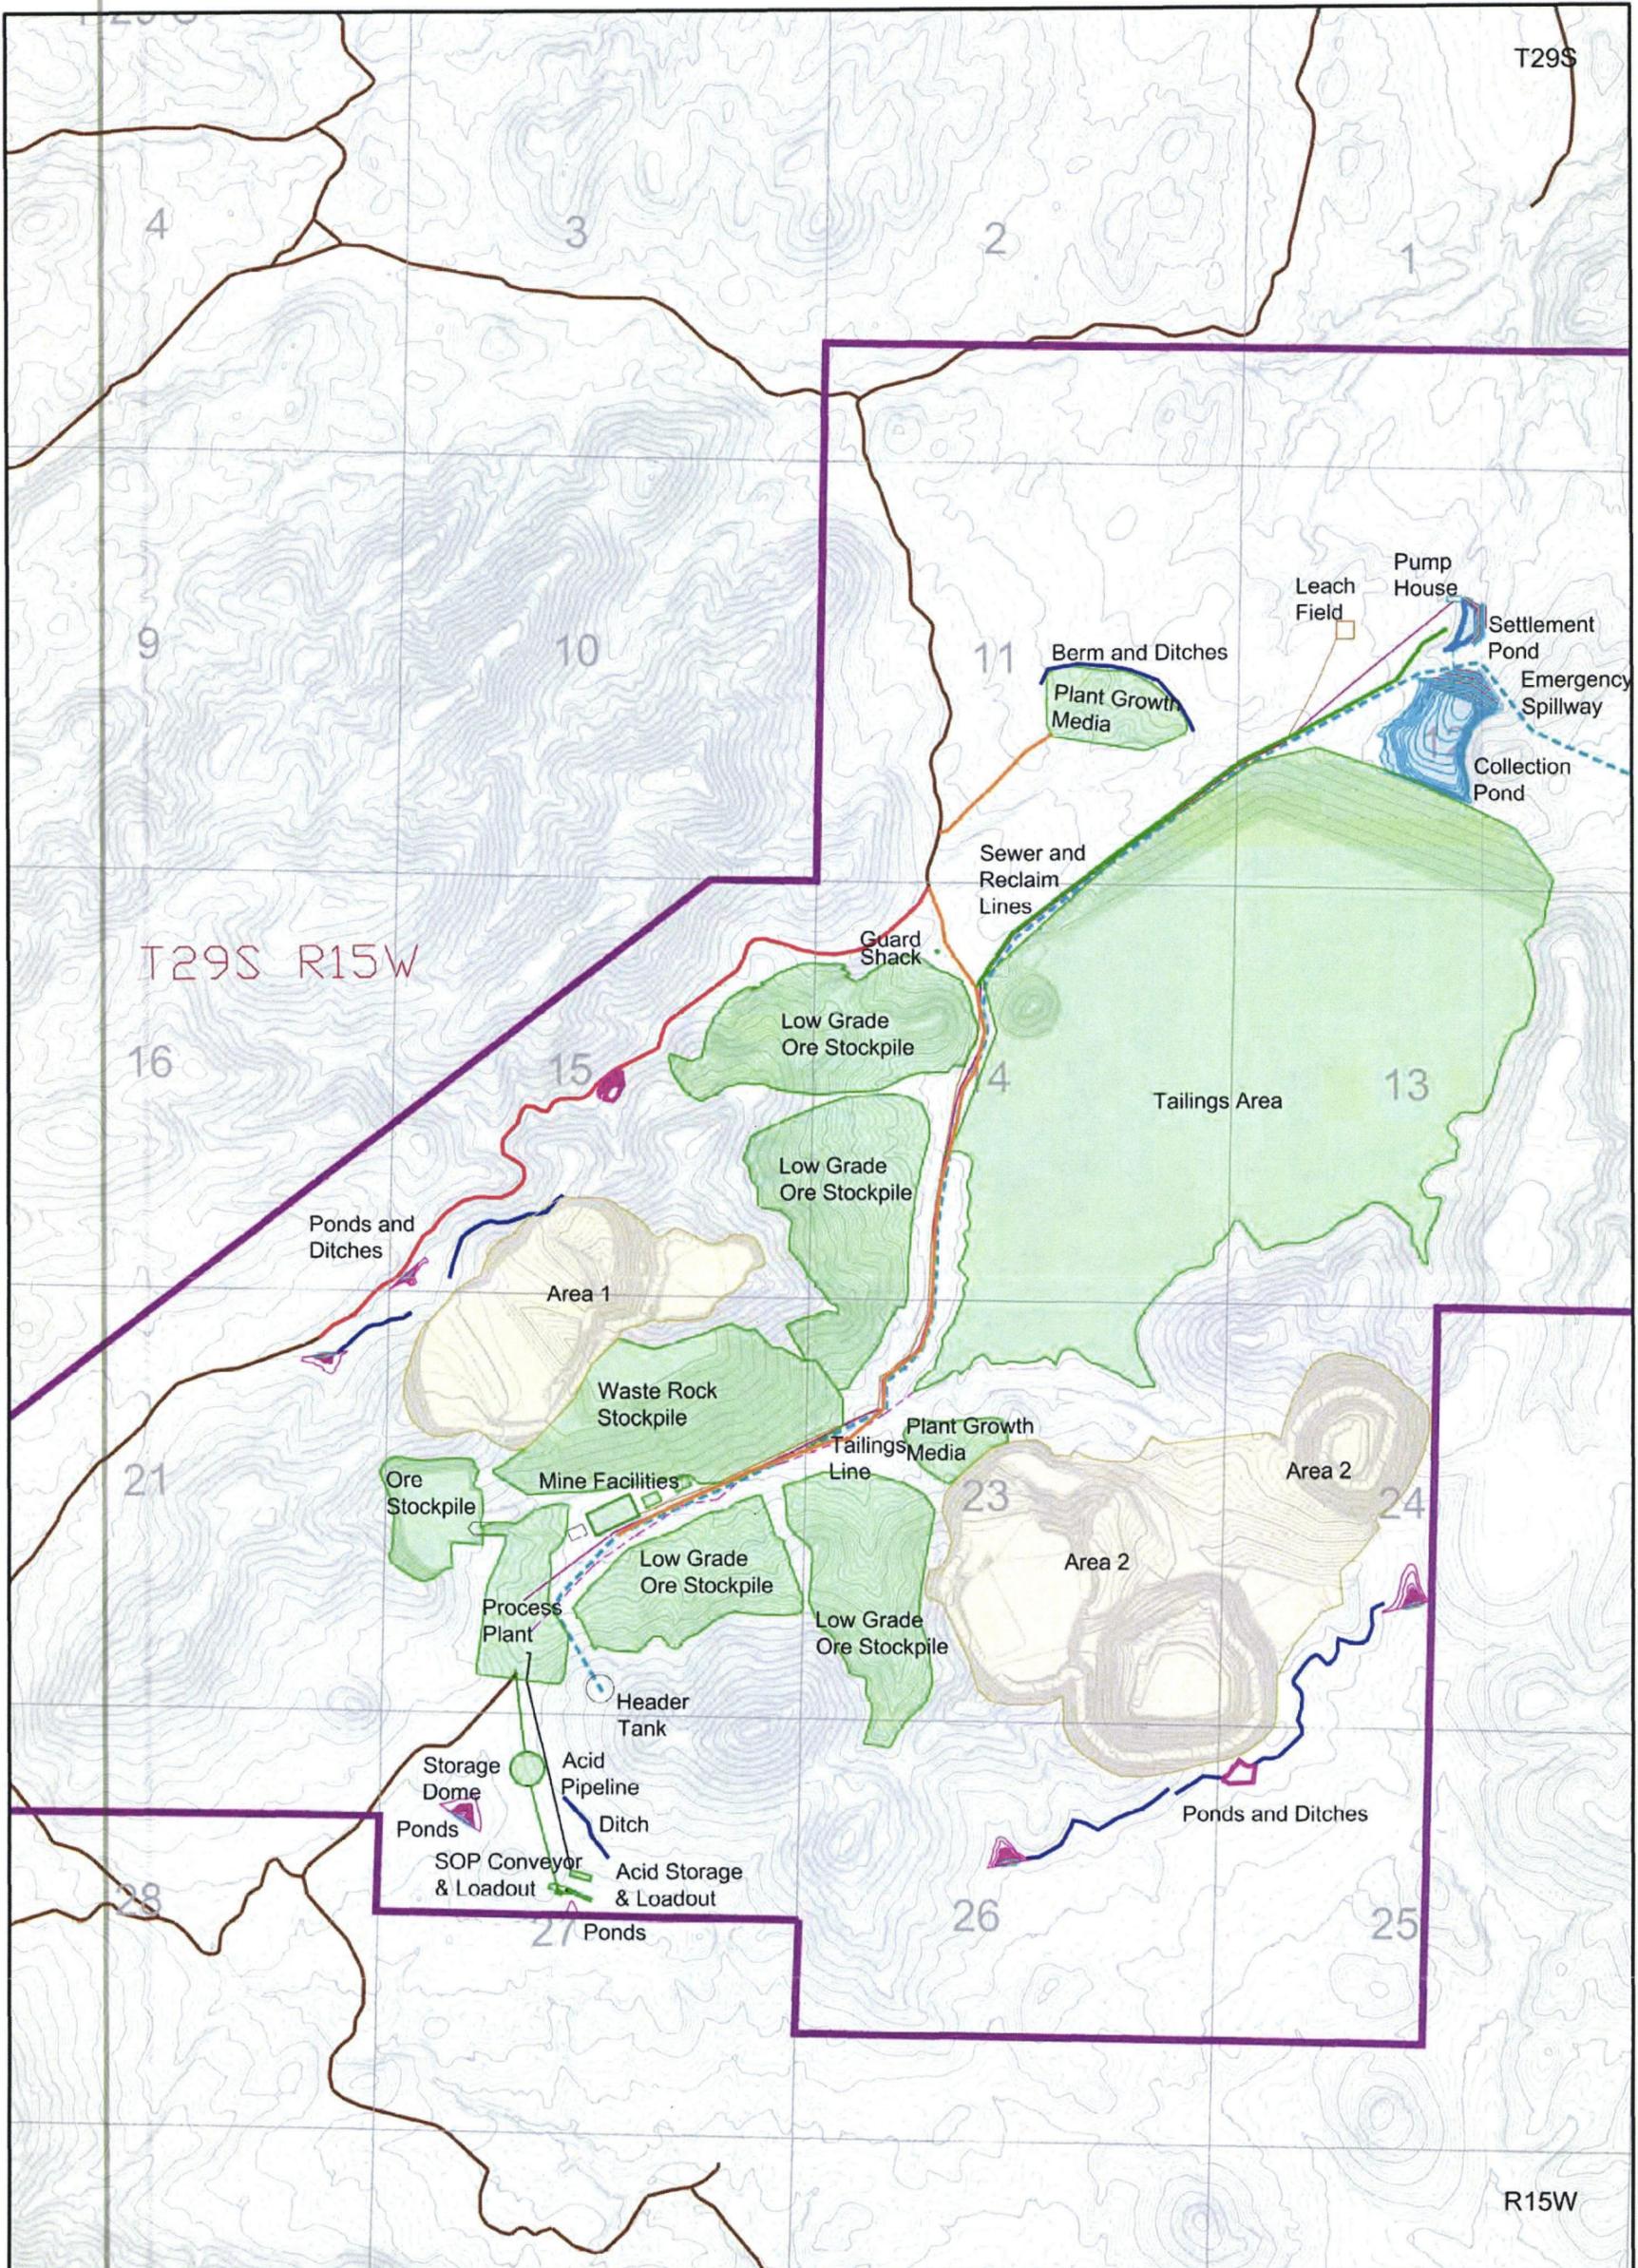
FIGURE 2

**BLAWN MOUNTAIN PROJECT
SITE LAYOUT**

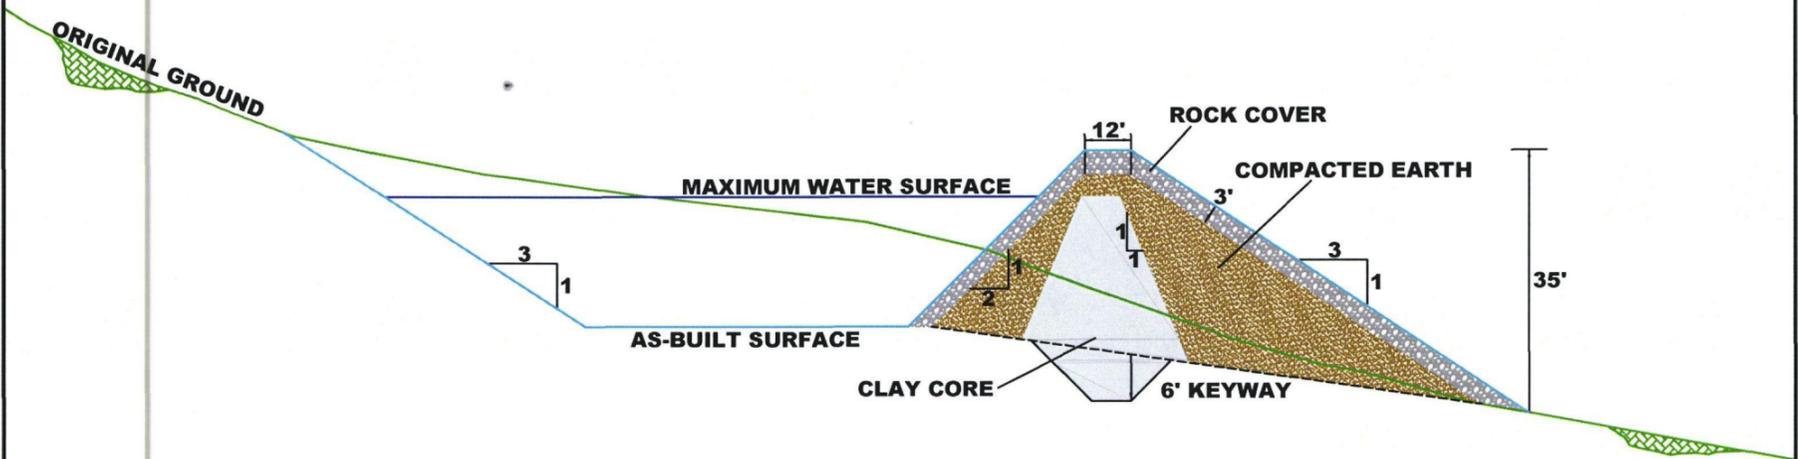
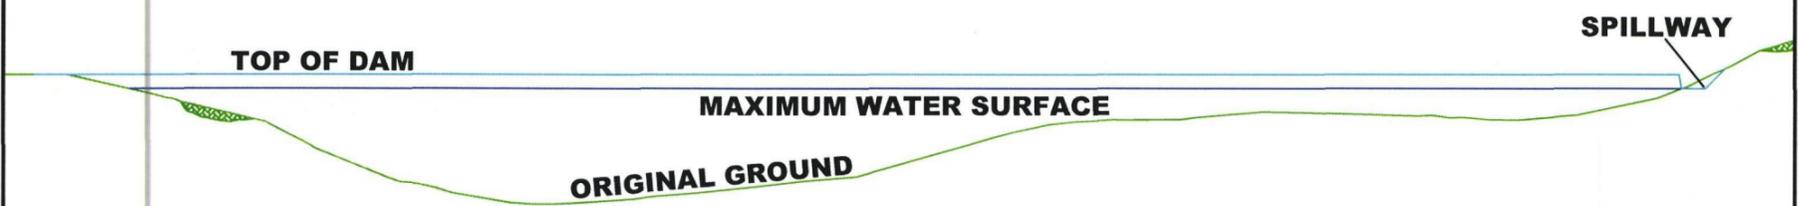
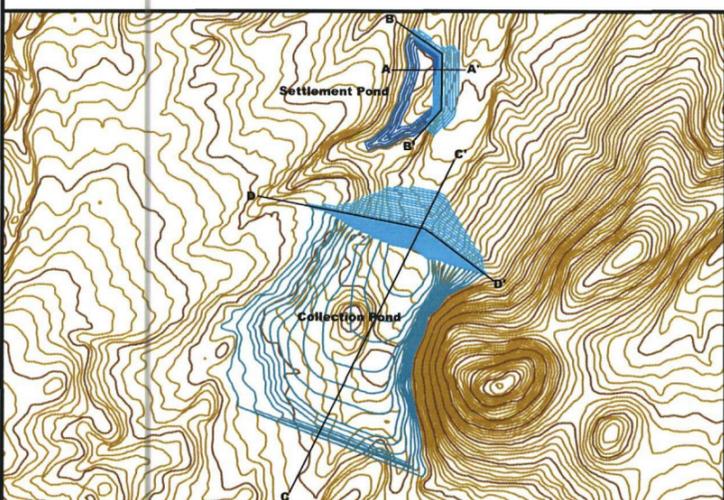
FIGURE 5

- NATURAL GROUND EXCAVATED TO CONSTRUCT EMBANKMENT
- ALL VEGETATION AND ORGANIC MATTER REMOVED PRIOR TO ANY CONSTRUCTION
- 2X VERTICAL EXAGGERATION

SECTION B - B' (PROFILE OF DAM)

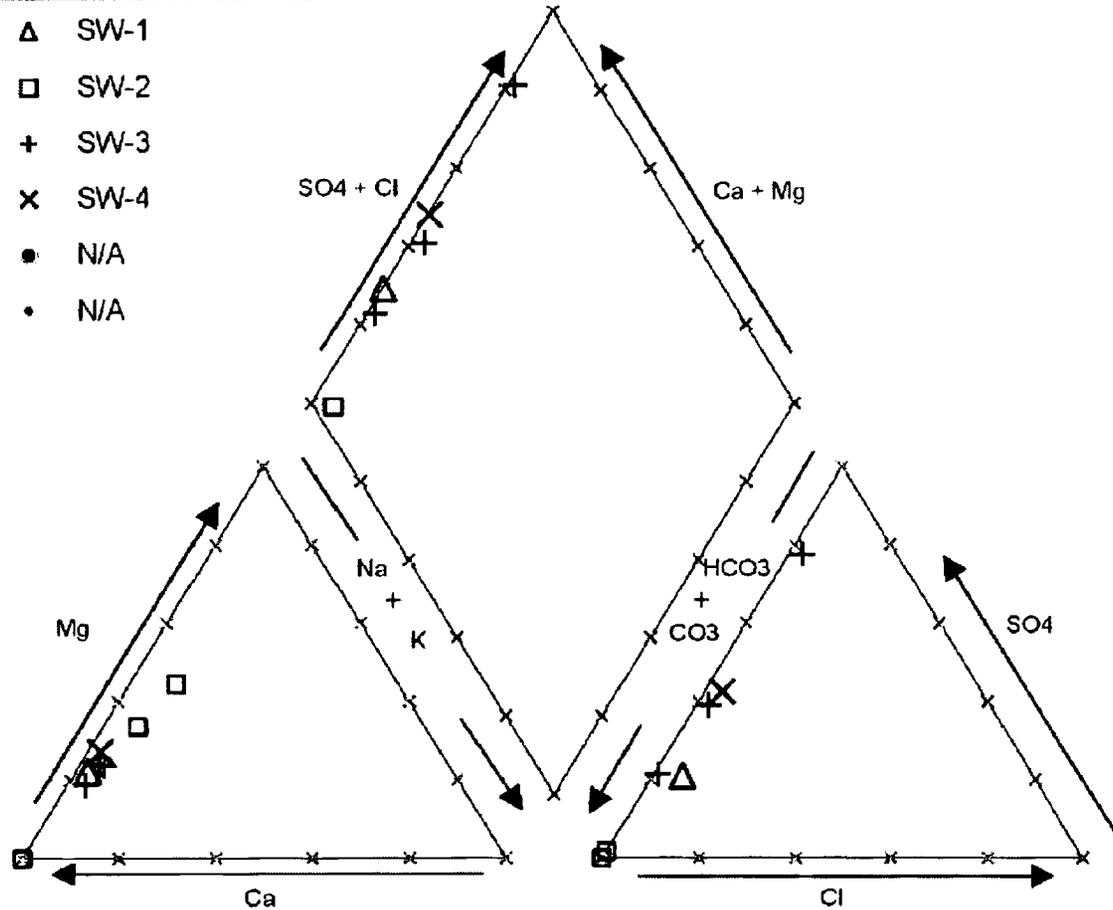
FIGURE 11

POTASH RIDGE CORPORATION
 BLAWN MOUNTAIN PROJECT
 SURFACE WATER
 PIPER DIAGRAM PLOT

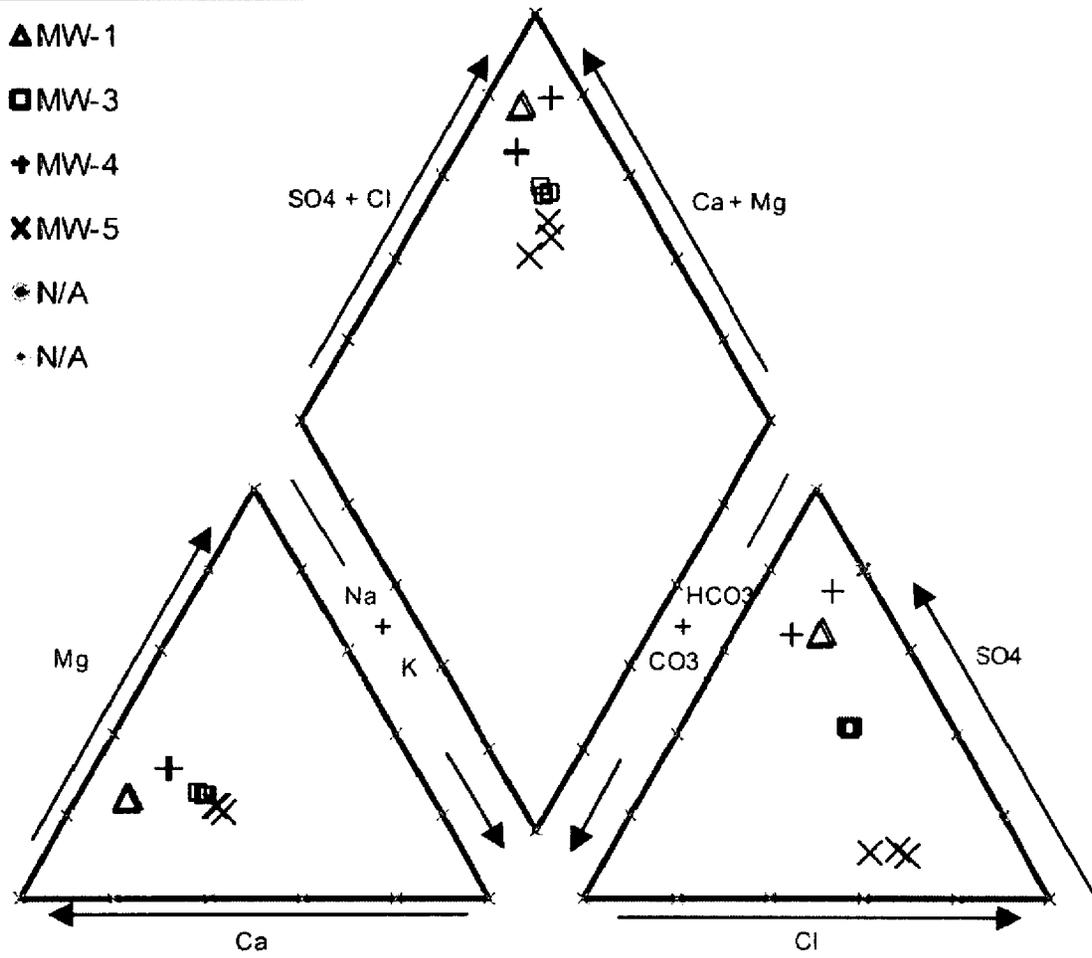
FIGURE 14

UTAH ALUNITE CORPORATION
BLAWN MOUNTAIN PROJECT
GROUNDWATER WATER
PIPER DIAGRAM PLOT

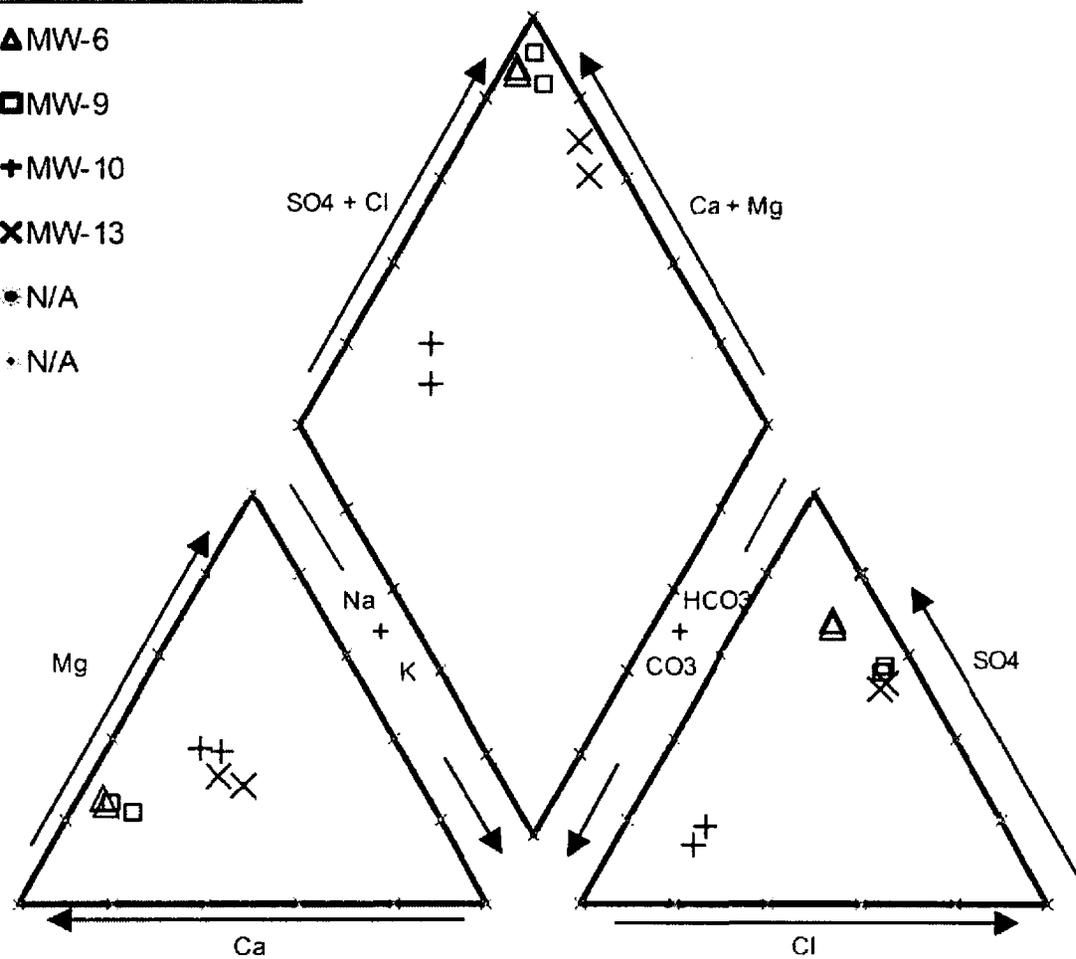
FIGURE 15

UTAH ALUNITE CORPORATION
 BLAWN MOUNTAIN PROJECT
 GROUNDWATER WATER
 PIPER DIAGRAM PLOT

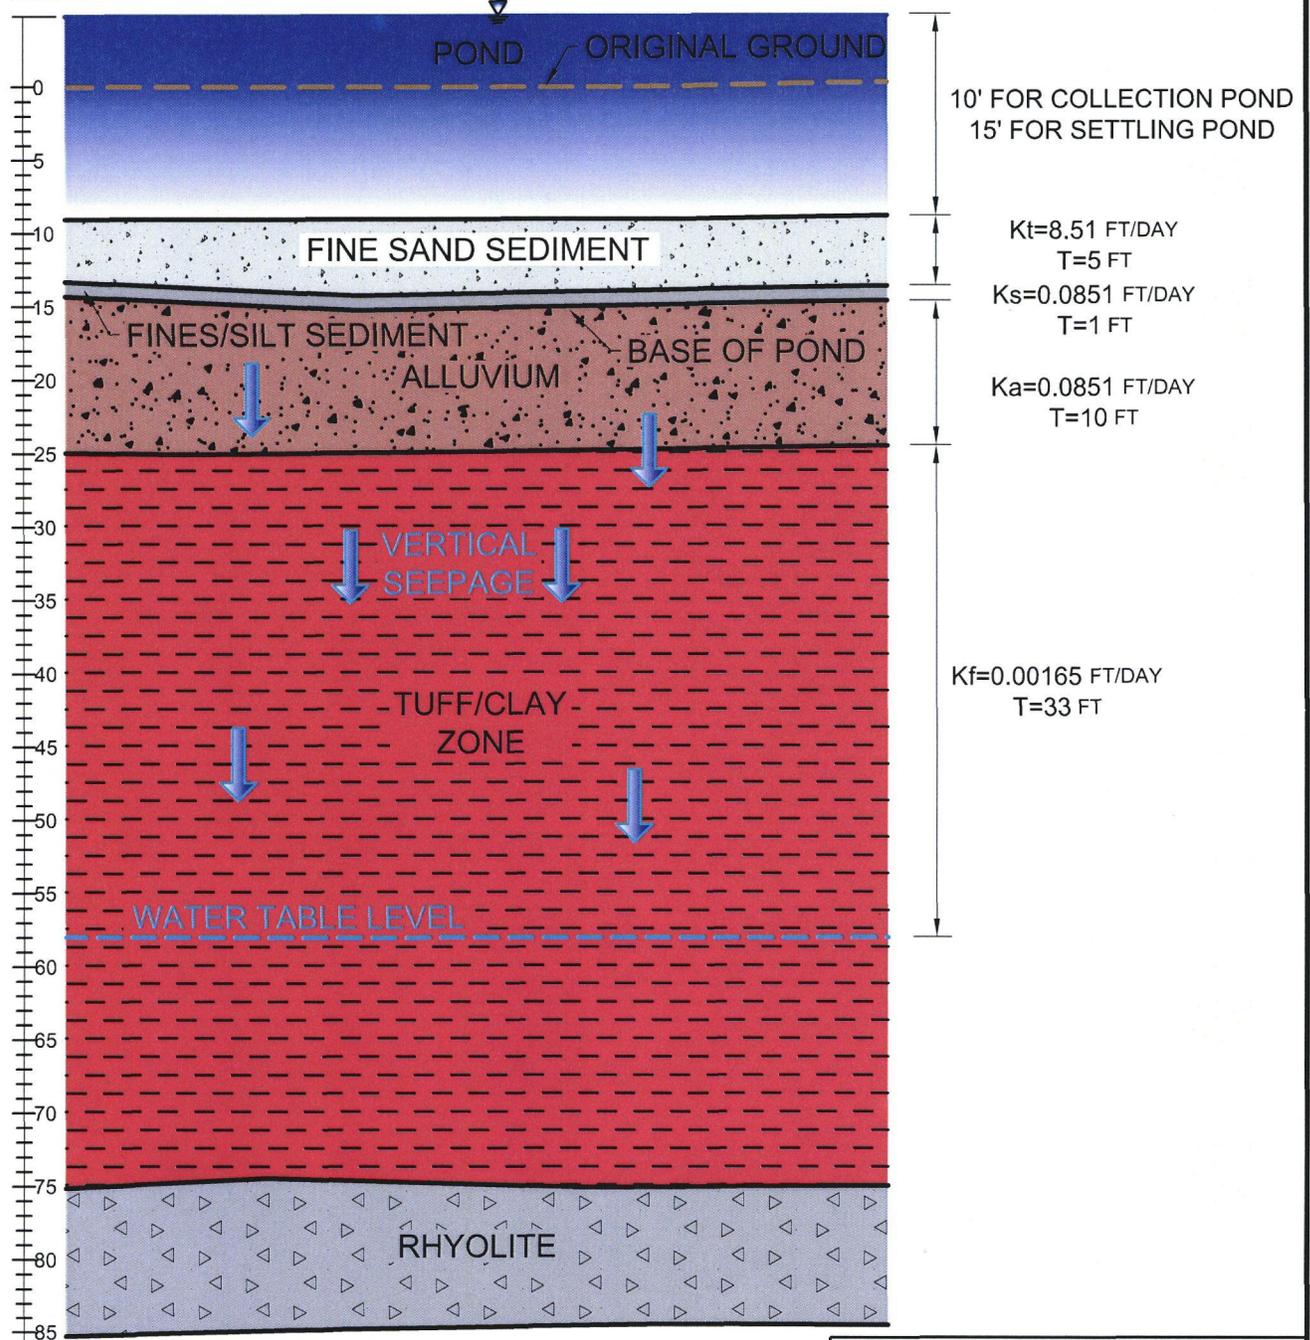
Travel Time: 483764.9 days~ 1325 years

1. Lithology from MW-3
2. Kt, Ks, and Ka from published values
3. Kf from MW-3 pumping test
